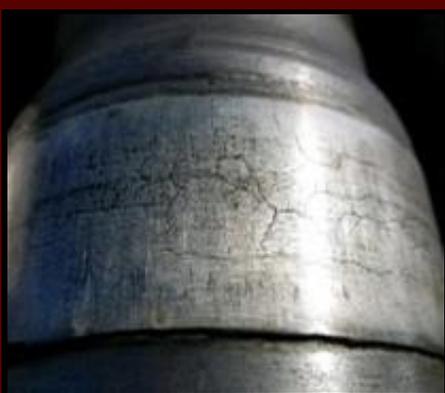
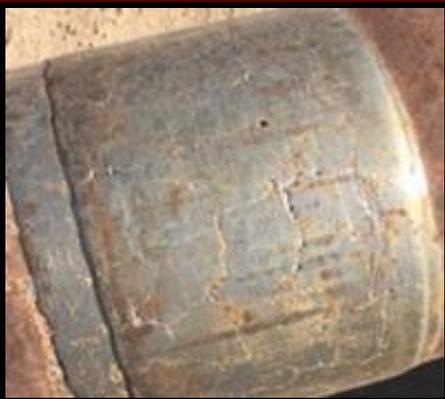
The photos above are two examples of hardbands exhibiting unacceptable cracking. Hardbanding in this condition should never have new hardbanding re-applied over them. It must be ground out and rebuilt before new hardbanding can be applied.

Good, effective hardbands are free of cracks, spalling, porosity, and voids. They also must meet dimensional criteria that makes their use more effective and allows them to wear well and protect the casing. Years ago, before the introduction of Duraband®NC, cracking hardbands were common and accepted. Even today there are still several hardbanding wires that crack. Below are some conditions when cracking can appear.

Some wires are designed to crack. It is a stress-relieving process and can be desirable in some *non-oilfield hardfacing* applications. Hardbanding on drill pipe is one of those applications where cracking should not be tolerated, especially on re-application. The chemical composition of the wire can dictate whether it will crack. Wires containing Boron, for example, are unpredictable and will have a much greater tendency to crack. On drill pipe, cracking can be an expensive process because these welds, sooner or later, will have to be removed by grinding them out and rebuilding the area removed. Cracking in the hardbands can also lead to accelerated casing wear.

Hardbanding is sensitive to what it is being applied over. During the welding process the alloy of the hardbanding wire is mixed with the material at the surface as it is being welded. If this surface is unstable for any reason, the new hardbands will likely show signs of it. Cracked, spalled, brittle, or contaminated hardbands are very difficult surfaces on which to reapply hardbanding. Additionally, previous hardbands containing Boron or Tungsten Carbide will often crack when new hardbanding is applied over them. Frequently the old weld must be ground out and then rebuilt before new hardbanding can be applied. A knowledgeable hardbander can occasionally go over some of these surfaces, but sooner or later, old or damaged bands will need to be removed.

All welding products have published parameters for proper and effective application. These parameters include torch and welding machine settings, shielding gas mixture and volume, along with pre-heating and post-cooling practices. Each wire has its own set of parameters and varying from the manufacturer's recommended parameters and procedures can produce unwanted results. Cracking is one possible outcome created by non-conformity to these parameters. Improper pre-heating is one of the most common procedure shortcuts which can result in compromised hardbands. Insufficient post cooling procedures is another procedural flaw that can produce unwanted results. Cracking is frequently the result of poor pre-heat and post cooling procedures.
