What to do with Eccentric Wear of hardbanding

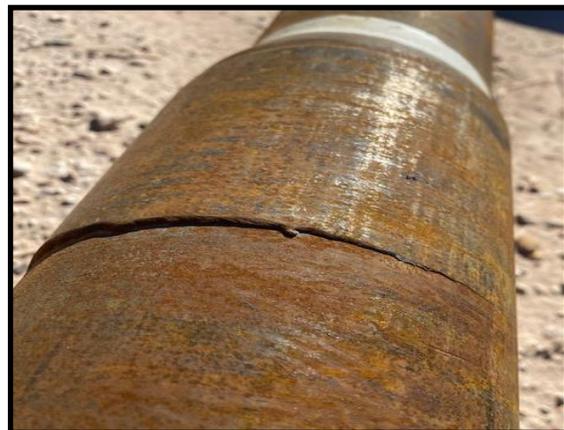
As the distance of horizontal laterals increases, so do the difficulties of managing wear on the tool joints of drill pipe. In a conventional drilling operation, the wear on the tool joint is typically more uniform. With long laterals, the drill pipe spends more time laying on its side and sliding along the well bore. The result is that the hardbanding can be completely worn away on one side while still having a lot of hardbanding material on the opposite side.

There are two possible solutions to hardbanding eccentrically worn tool joints. The first, and most common, is to remove the existing hardbanding. This process can be labor intensive and expensive. Another option is to apply partial hardbands only in the area that has worn. This option saves time and the expense of removal, but should only be performed by experienced hardbanding operators. The pipe owner should be notified and agree to the application of partial hardbands.

Postle Industries created a procedure to apply partial hardbands with both of our Duraband® NC and Tuffband® NC products. This procedure is detailed in our Hardbanding Recommended Procedures (HRP) Manual. Postle Industries only endorses partial hardbanding over its own products and not over competitive hardbanding materials. Partial banding is a cost effective way to rebuild eccentrically worn tool joints.
